UNITED STATES ENVIRONMENTAL PROTECTION AGENCY
REGION 8

SUBJECT: Libby Asbestos Site, Operable Unit 3
Section 5.0 of the Phase III Sampling and Analysis Plan
Proposed Geotechnical Investigations

5.0 OTHER DATA NEEDS FOR RI/FS

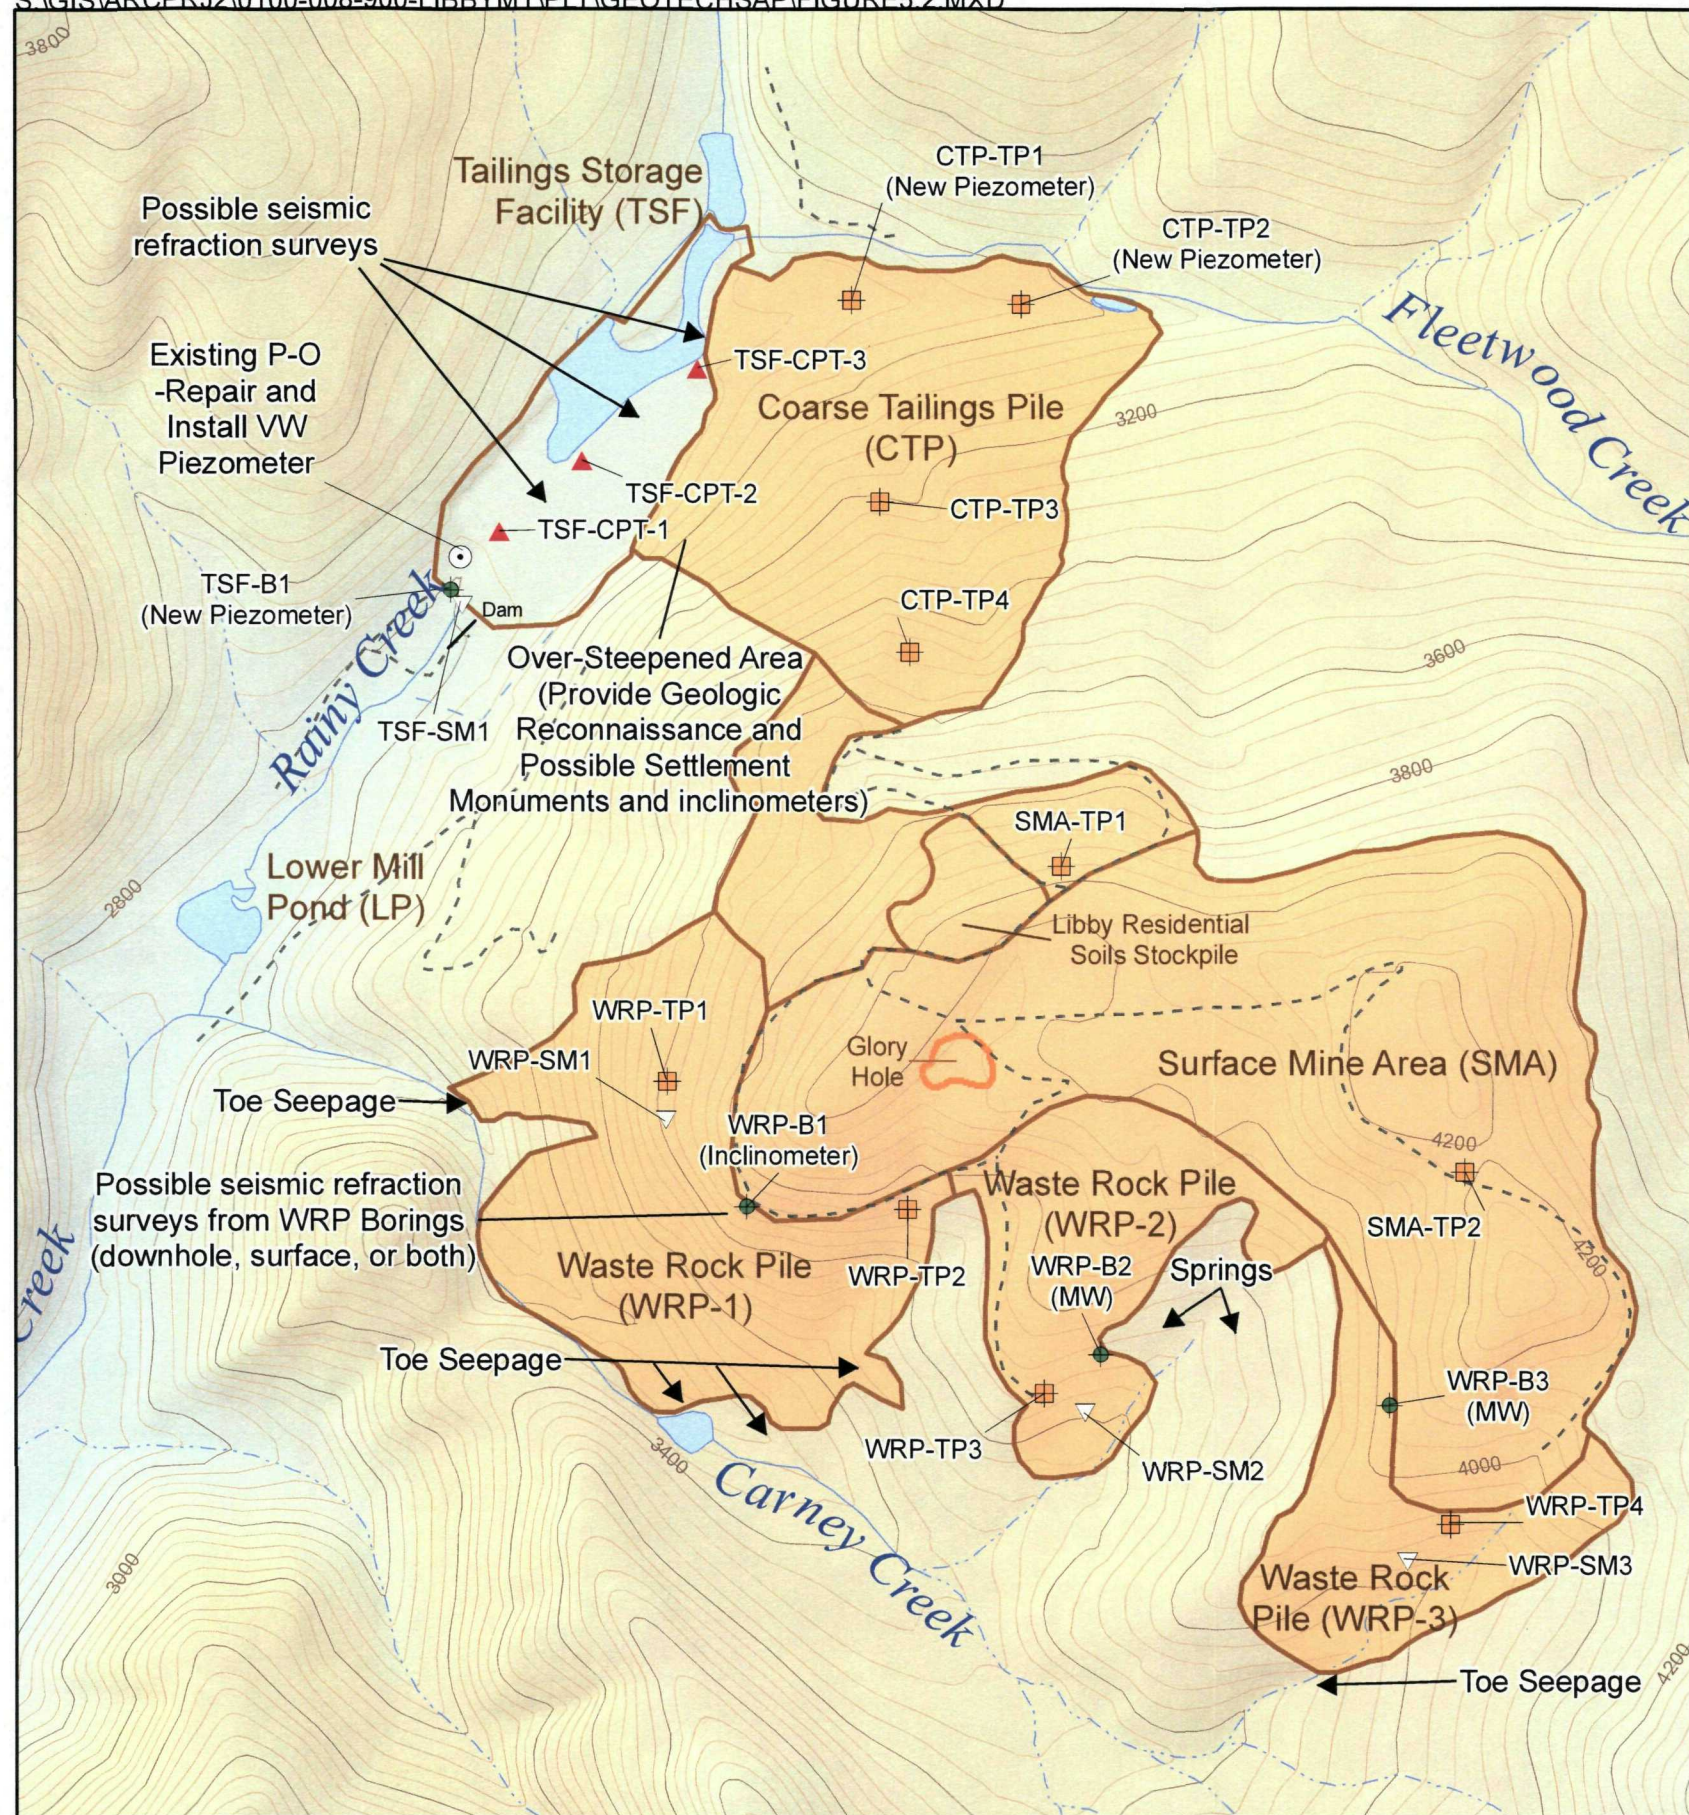
Settlement Monuments at TSF and WRP areas not shown and existing MWs not indicated although water level measurements required from all existing MWs

- Mine Roads
- Glory Hole Area
- Mine Disturbance Areas
- Mine Disturbance
- ◆ Proposed New Borings (4)
- ▲ Proposed Cone Penetrometer Test (3)
- ⊠ Proposed Test Pits (10)
- ⊙ P-O Existing Non-Functional Piezometer
- ▽ SM-Proposed Settlement Monuments (4)
- MW New Groundwater Monitor Wells
